Water Resources Department

May 30, 2017

Re: Crowley Dam (C 10) – Special dam safety notice

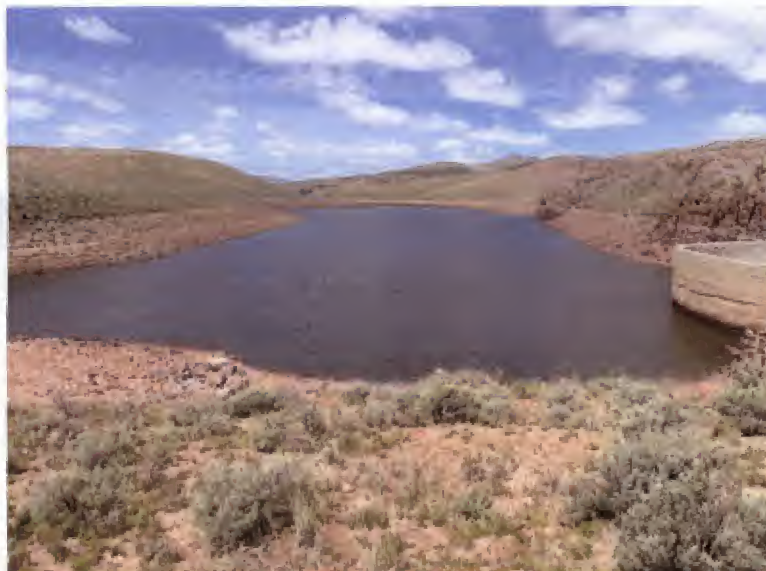
Crowley reservoir on 5-2-17

The reservoir level was about 35 feet below the dam crest when inspected. Early this year, water had flowed over the crest of the dam for about a month. A full reservoir

results in hydraulic forces on the dam, and any offset in cracking could result in catastrophic failure.

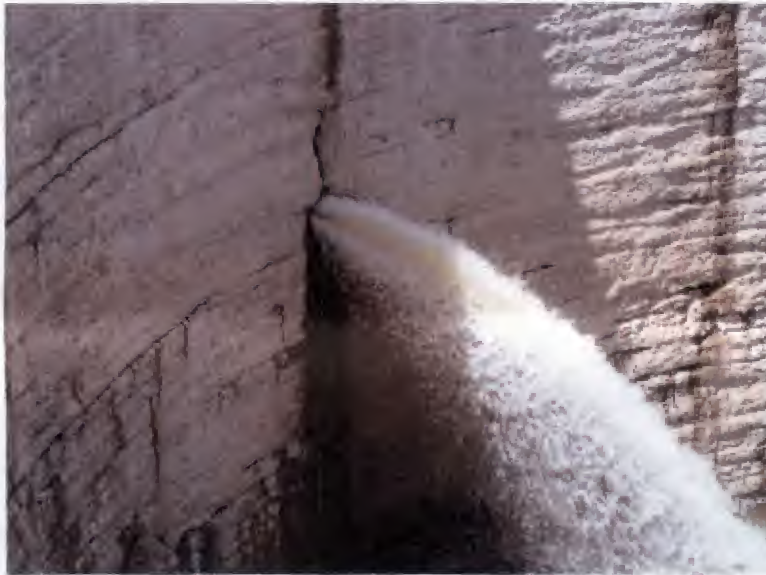
Hole through dam appears larger

As noted in the last two inspection reports, the dam is no longer serviceable. Crowley dam has been allowed to deteriorate over the course of many years. The most significant changes to the dams' condition since the last inspection are the enlargement of the hole associated with a significant vertical crack in the face of the dam.

Necessary Action: I would consider an engineered design a temporary repair that includes a time frame that the repair may be used. I would only consider a repair plan that is developed by and stamped by a professional engineer registered in Oregon. A list of potential engineers was e-mailed to you on May 9th of this year. **No later than June 20, 2017, send me the name of the engineer that will be working for you on this dam.** If an engineer is unable to develop a safe repair, valve removal is the only means of reducing risk at this dam. **If the valves cannot be opened, they should be cut off with a torch to keep them as open pipes through the dam.**

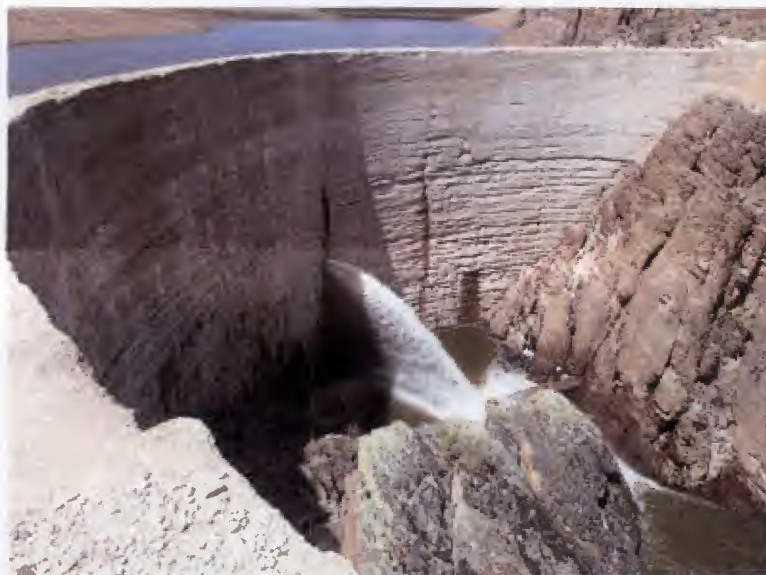
Downstream face showing cracks and leaks

As another reminder, concrete arch dams are likely to fail suddenly, catastrophically, and without warning. Removal of Crowley dam will be needed very soon even if short term repairs are possible. The two valves to control flow through the dam are below and

obscured by the leak, and are both inoperable. Unless a short term repair is designed by an engineer and completed very quickly, the valves need to be modified so that they remain fully open. Open pipes will greatly reduce the risk of the reservoir filling. It remains of critical importance to prevent water building up a hydraulic load on the arch of the dam where any movement could cause failure. Persons below the dam, including anyone in your house or on the road below the dam are at significant risk when the reservoir behind the dam is full.

Remove valves or repair (short term) prior to wet season
